Flood Control Project Maintenance
2016 Structure Summary Report
Overall Unit and Item Ratings

Reclamation District No. 2096 Wetherbee Lake

Wetherbee Lake Pumping Plant & Navigation Gate

Flood Control Project Maintenance**Unit Cover Sheet****2016 Pumping Plant Inspection Results****Reclamation District No. 2096 Wetherbee Lake**

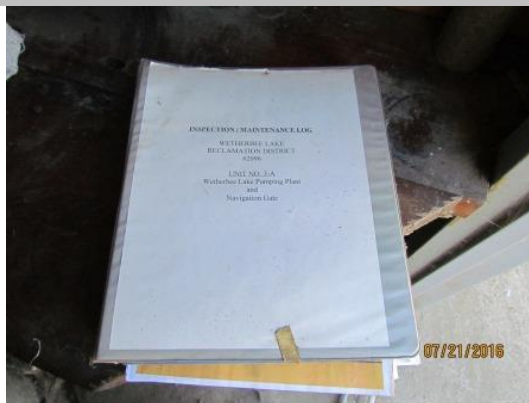
Photo 1 of 1 : ST_2016_RD2096_56_1_20160729_00014.jpg

| Inspector Comments: O&M log presented at time of inspection | | | | | |

View of the Operating Log and O&M Manual.

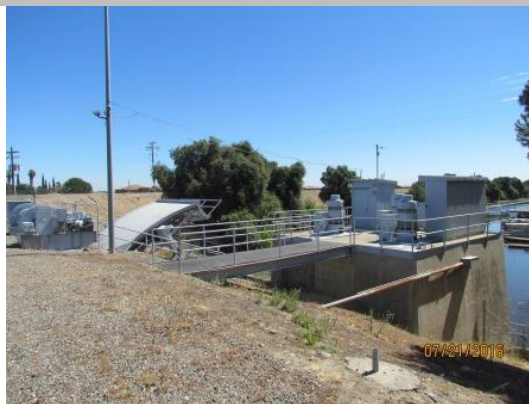
Photo 1 of 2 : ST_2016_RD2096_56_3_20160729_00025.jpg

| Inspector Comments: Building protects the controls only. | | | | | | |

View of the pant building and the radial gate.

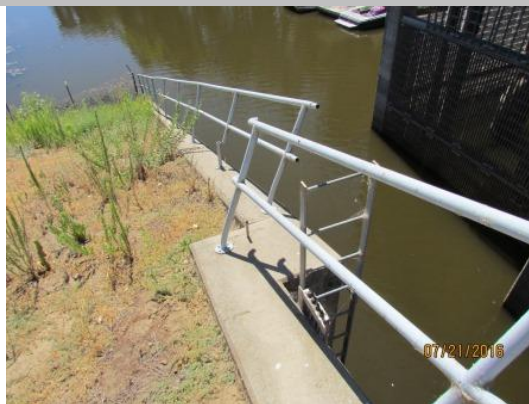
Photo 1 of 1 : ST_2016_RD2096_56_5_20160729_00016.jpg

| Inspector Comments: Missing guard rail on navigation canal. Missing fire extinguisher. | | | | | |

View of the missing guard rail.

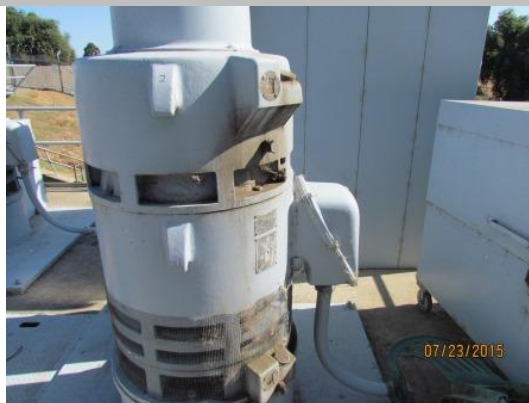
Photo 1 of 2 : ST_2016_RD2096_56_10_20160615_00004.jpg

| Inspector Comments: All items appear operational. | | | | | |

Close up view of the pump motor.

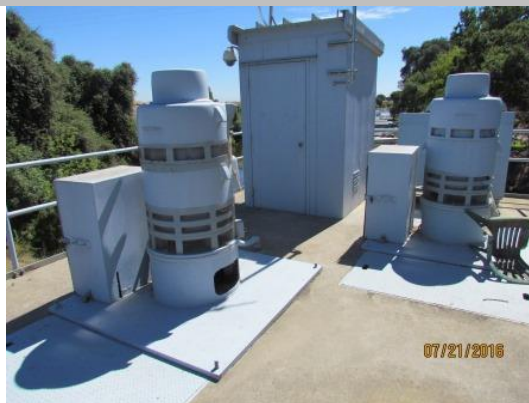
Photo 2 of 2 : ST_2016_RD2096_56_10_20160729_00017.jpg

View of the pump motors.

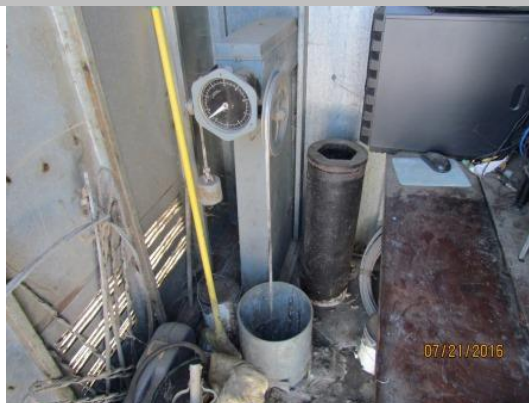
Photo 1 of 1 : ST_2016_RD2096_56_11_20160729_00027.jpg

| Inspector Comments: Controls are free of damage and appear to operate normally. | | | | | |

View of the water level monitoring system that automatically controls the pumps.

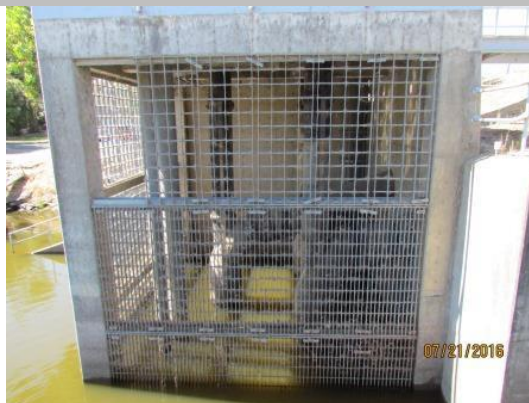
Photo 1 of 1 : ST_2016_RD2096_56_12_20160729_00018.jpg

| Inspector Comments: Sump is clear of debris. | | | | | |

View of the pump intake system. Note the missing grate at top left corner.

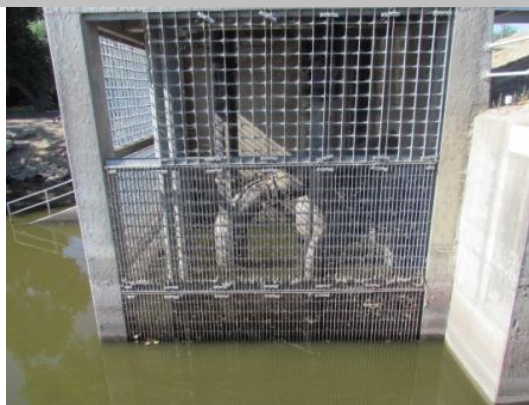
Photo 1 of 1 : ST_2016_RD2096_56_13_20160615_00006.jpg

| Inspector Comments: Trash rack is present, however one panel is missing from rack. | | | | | |

Section of trash rack is missing, missing section would be in upper left of photo.

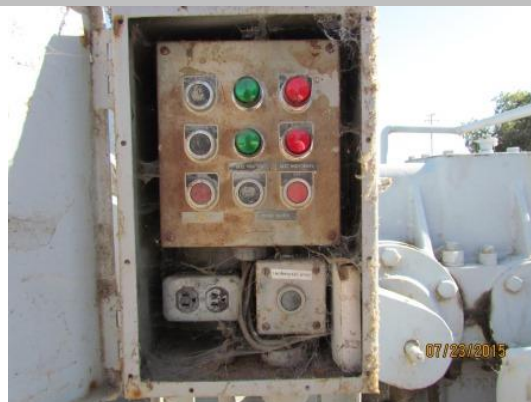
Photo 1 of 3 : ST_2016_RD2096_56_16_20160615_00008.jpg

| Inspector Comments: Item appears to be in good working condition. Radial arm gate was open at time of inspection. | | | | | |

View of the gate controls.

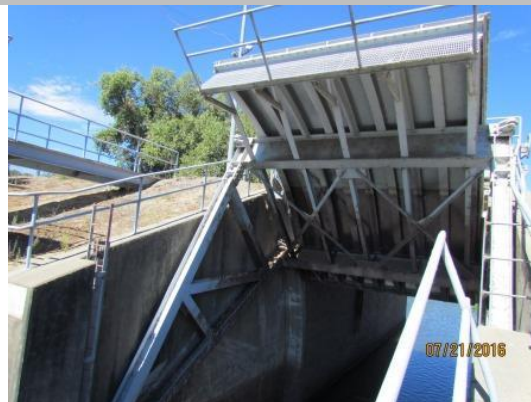
Photo 2 of 3 : ST_2016_RD2096_56_16_20160729_00019.jpg

View of the radial arm gate in the open position.

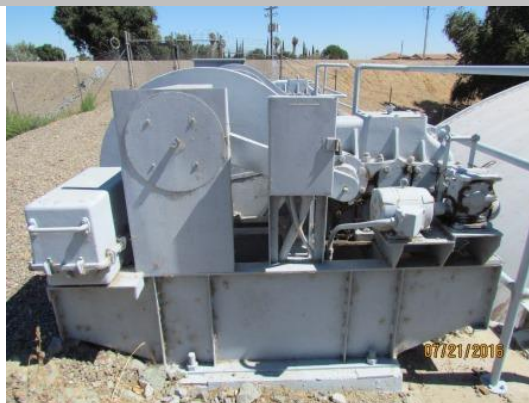
Photo 3 of 3 : ST_2016_RD2096_56_16_20160729_00026.jpg

| Inspector Comments: Item appears to be in good working condition. Radial arm gate was open at time of inspection. | | | | | | |

View of the electric gate operation mechanism.

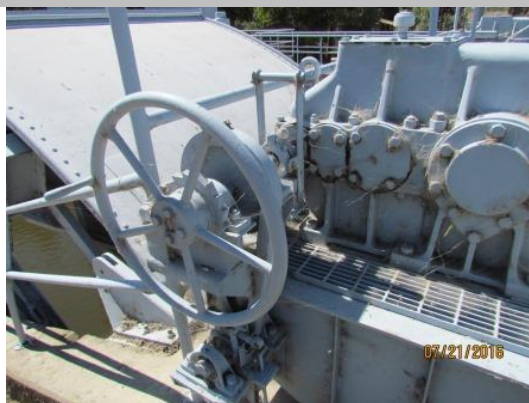
Photo 1 of 1 : ST_2016_RD2096_56_17_20160729_00020.jpg

| Inspector Comments: The LMA has the ability to engage the manual system should electric operation fail. | | | | | |

View of the manual gate operation control.

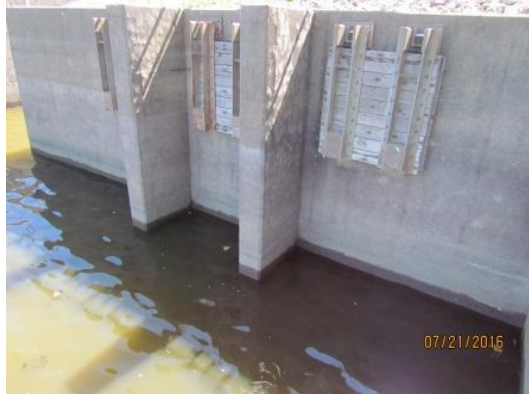
Photo 1 of 1 : ST_2016_RD2096_56_19_20160729_00021.jpg

| Inspector Comments: Flap gates appear to be fully operational. | | | | | |

View of the flapgates.

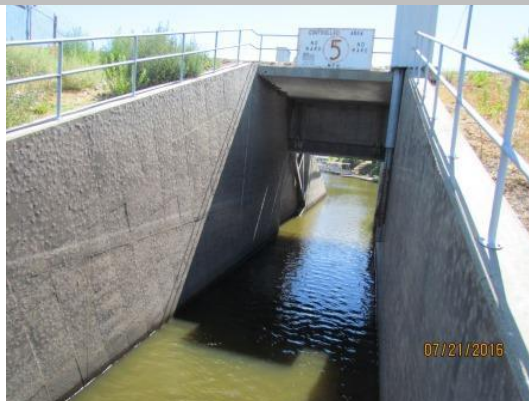
Photo 1 of 1 : ST_2016_RD2096_56_20_20160729_00022.jpg

| Inspector Comments: Radial arm gate acts as closure structure, gate was open at time of inspection. | | | | | |

Radial arm gate, shown in open position.

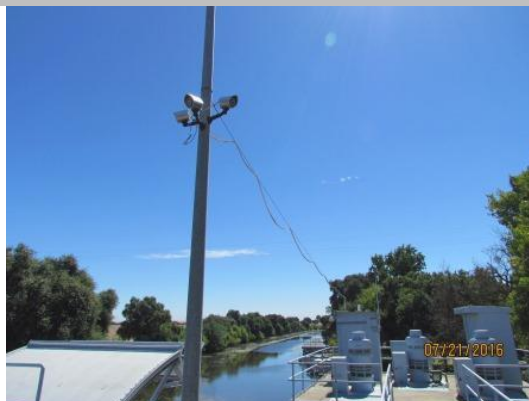
Photo 1 of 2 : ST_2016_RD2096_56_21_20160729_00024.jpg

| Inspector Comments: Security fencing is in place. Closed circuit cameras are also in place. | | | | | |

View of the security cameras at the facility.

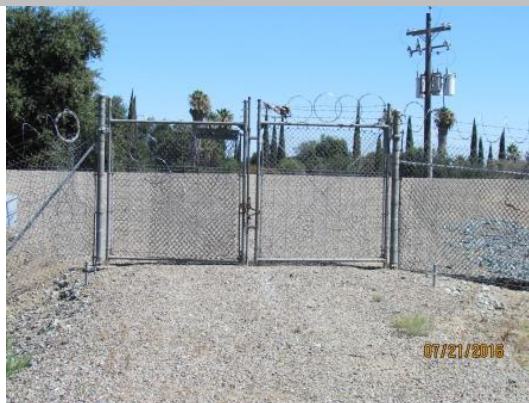
Photo 2 of 2 : ST_2016_RD2096_56_21_20160729_00023.jpg

| Inspector Comments: Security fencing is in place. Closed circuit cameras are also in place. | | | | | | |

View of the security fencing around the facility.

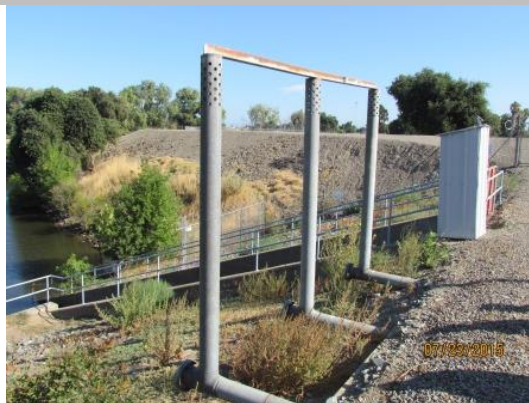
Photo 1 of 1 : ST_2016_RD2096_56_22_20160615_00013.jpg

| Inspector Comments: Pipes appear to be free of defects. | | | | | | |

View of the siphon breakers at the levee crown.
